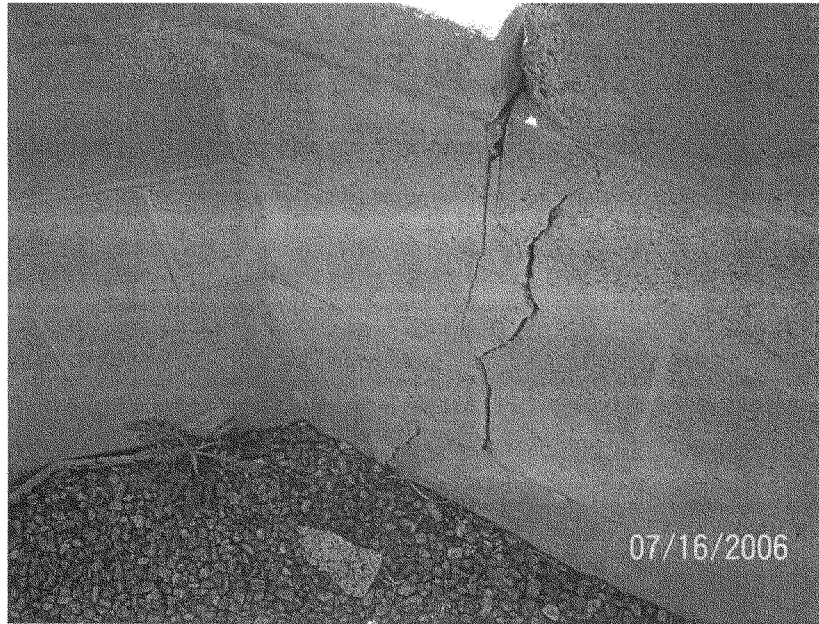
Rapid settling at another corner. Crack is caused by uneven settlement of the foundation

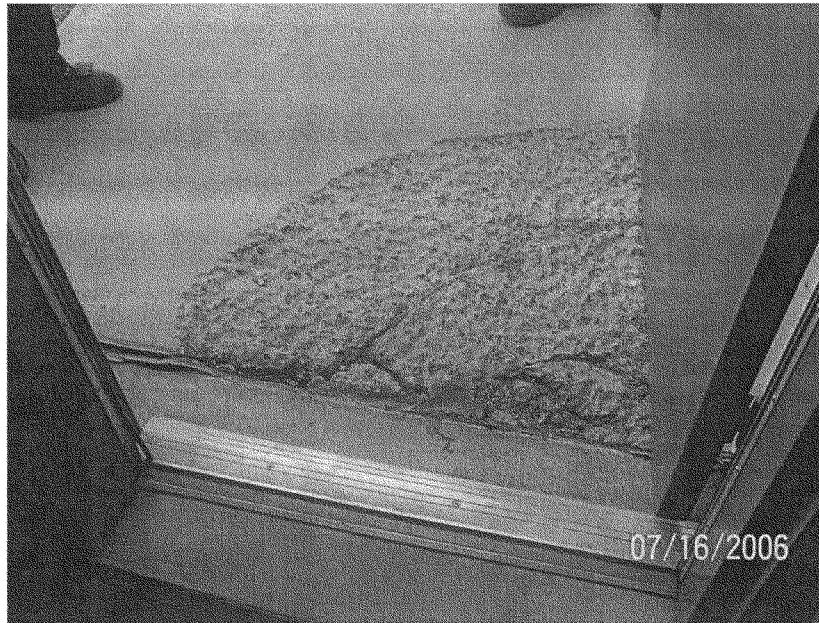
Building and the door has settled approximately 1 inch. Concrete is constantly scraped to allow opening of the door

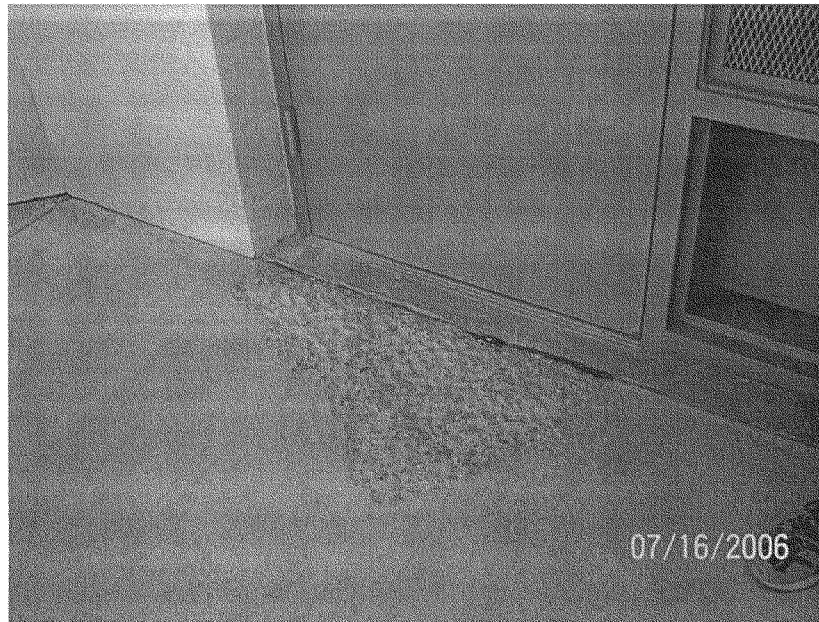
All exterior doors have sunk, some faster than others

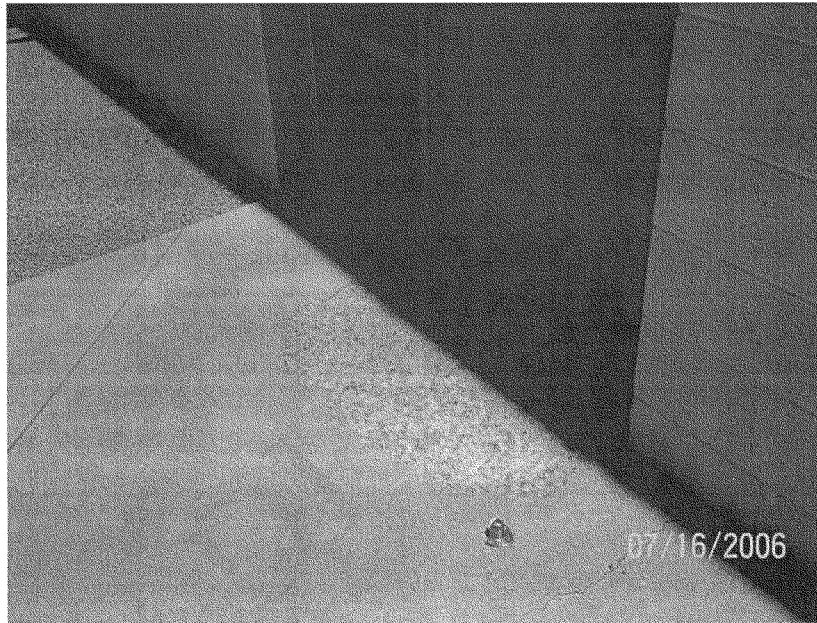
All exterior doors have sunk, some faster than others

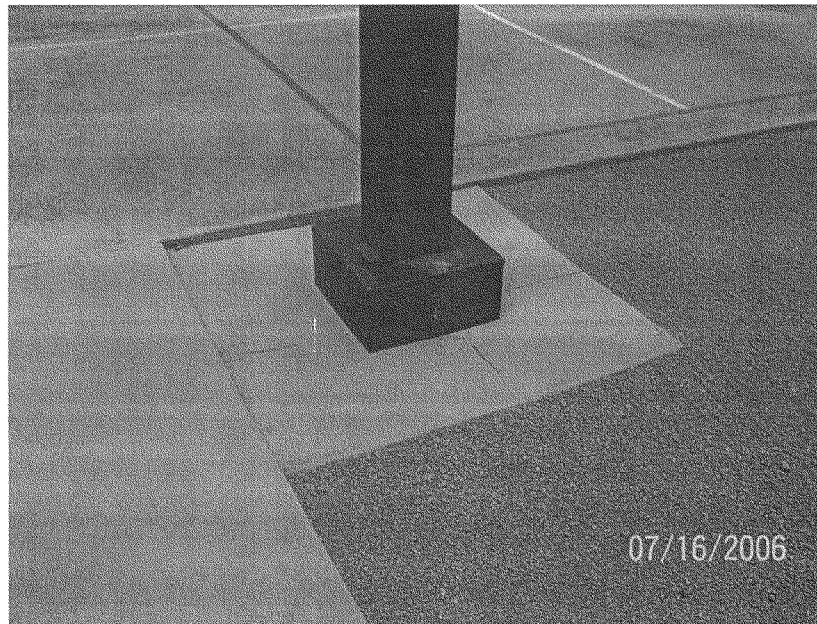
Concrete footing at the base of this outdoor light fixture – that has a vertical weight of about 300 pounds, has settled about 1 inch

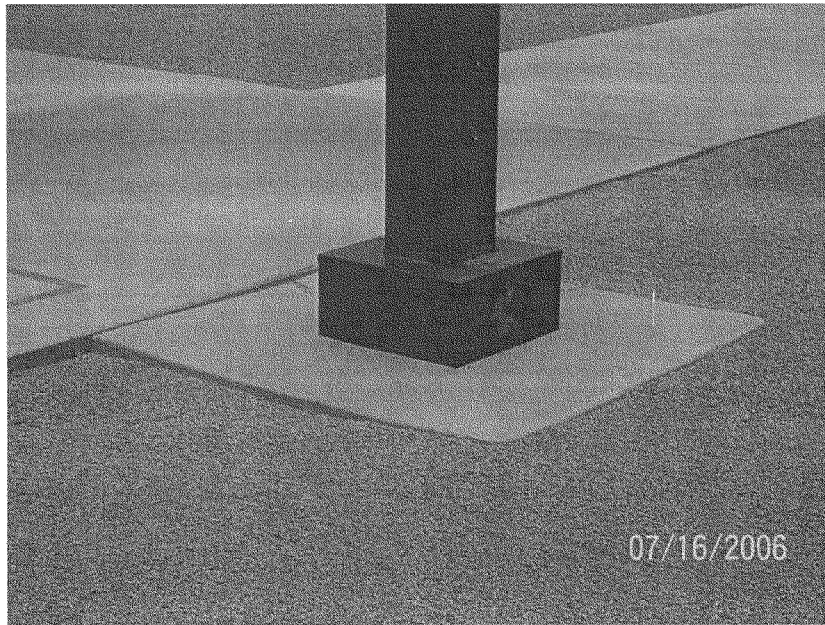
Close-up of the picture on the previous page. Compare the left edge to the right edge of the base for this light fixture

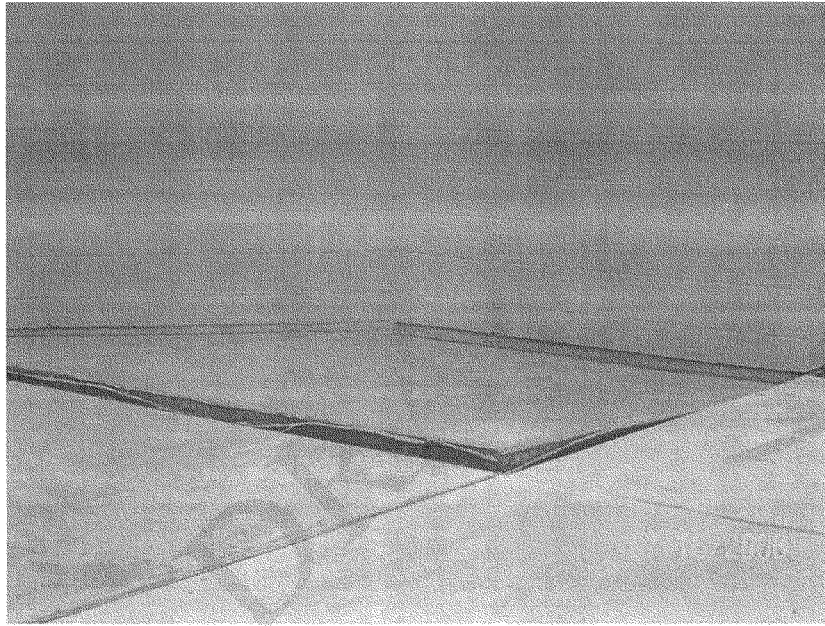
The weight of the building has settled it, leaving the connected but adjacent slab to lift about 4 inches

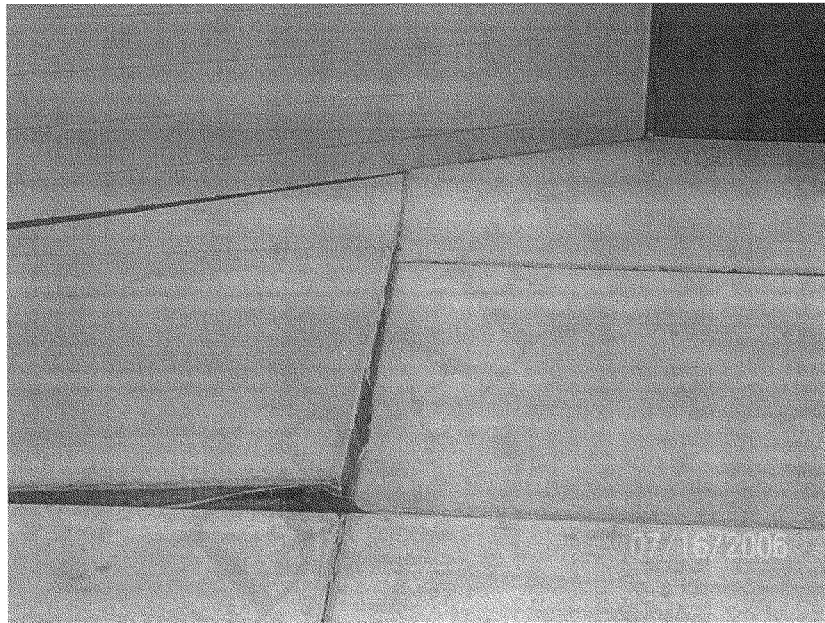
This 4 inch uplift of the slab has occurred in less than 3 years. The building is 7 years old.

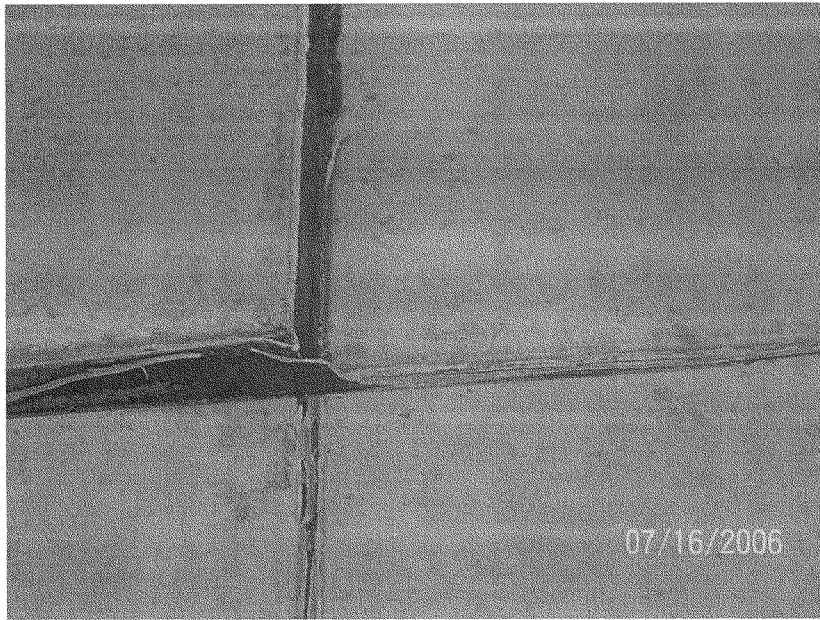
Close-up of the picture above

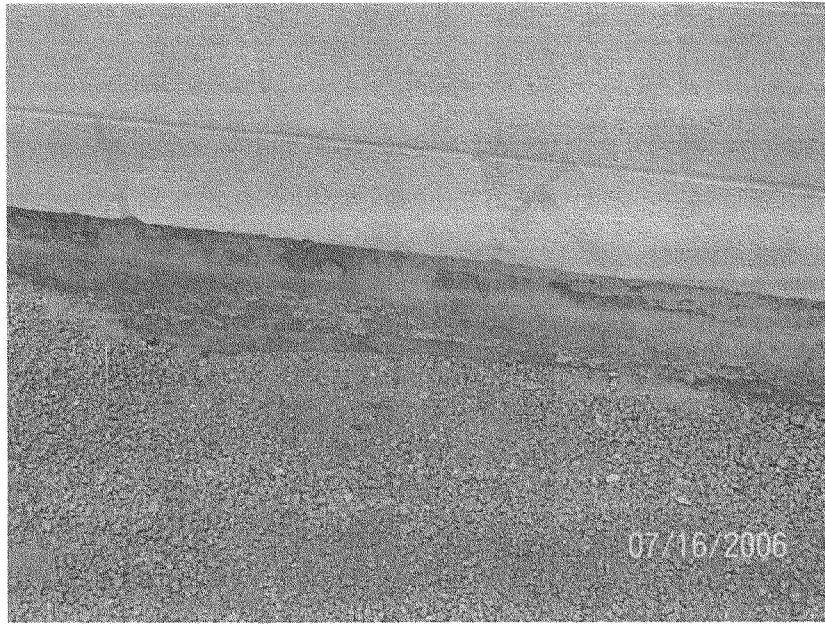
Collapsed soil along the weight-bearing edge of the building

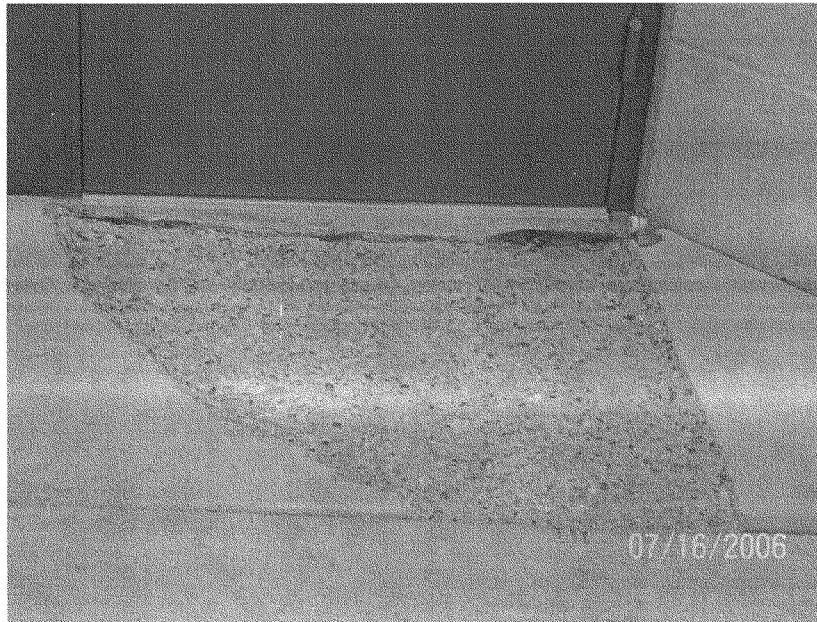
Concrete scraped about 1 inch to allow opening of the exterior door

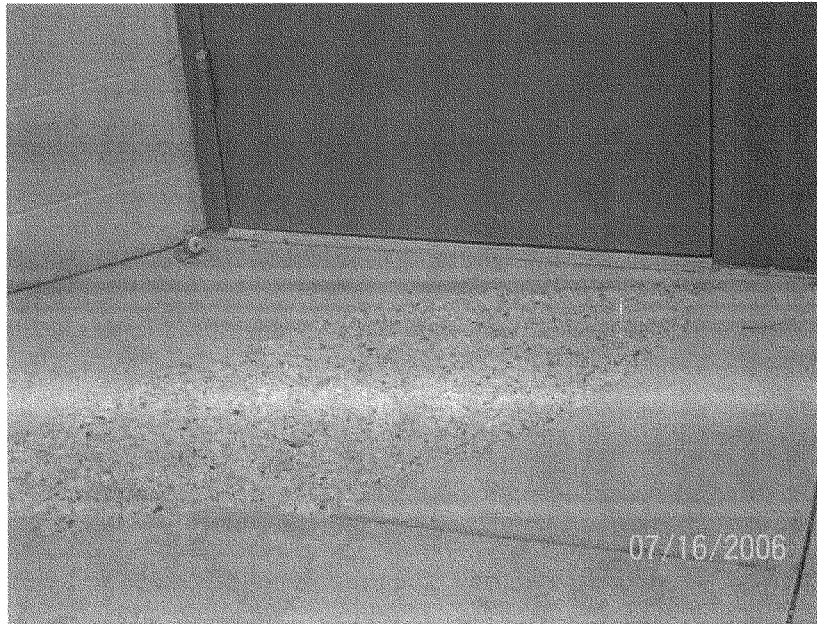
Another exterior door settling slower than others

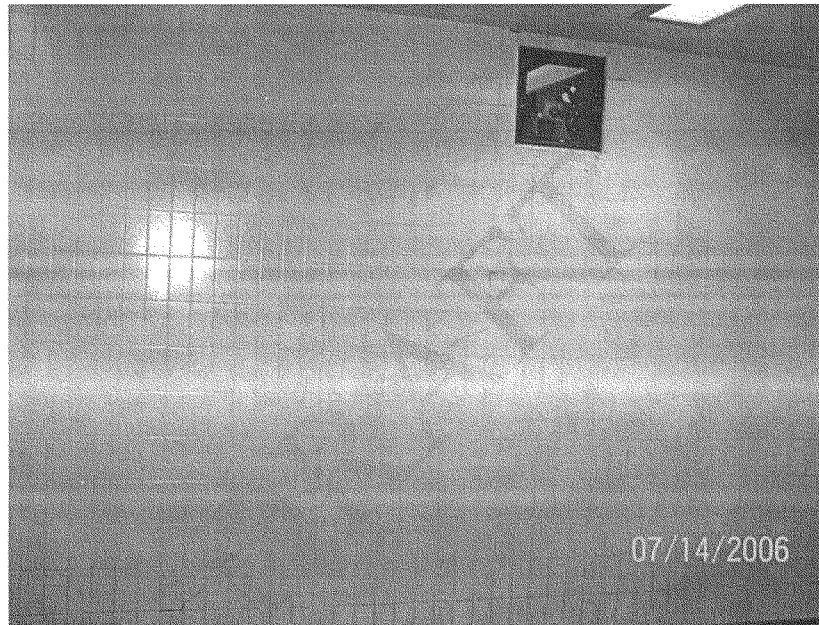
Stress cracks at 45 degree angle indicate settling of the foundation

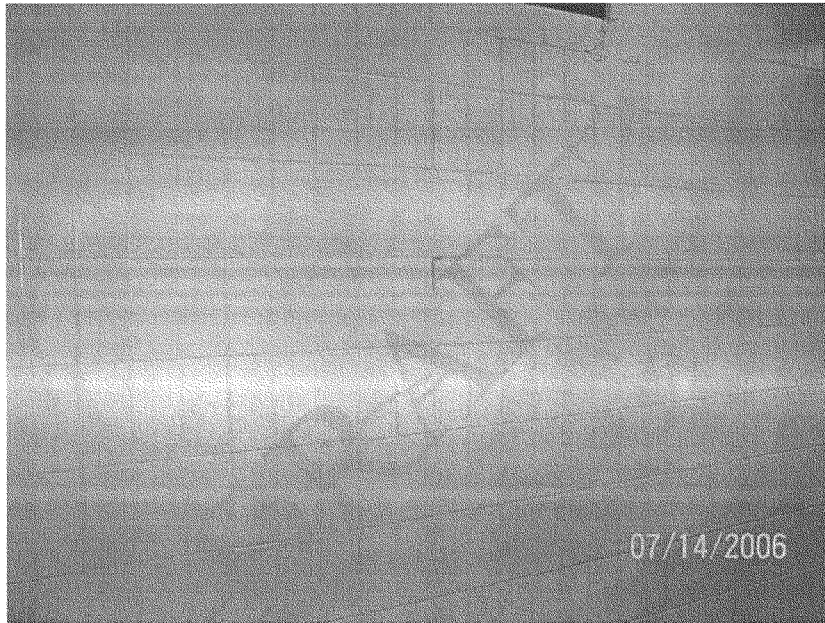
Close-up of the crack shown on previous page

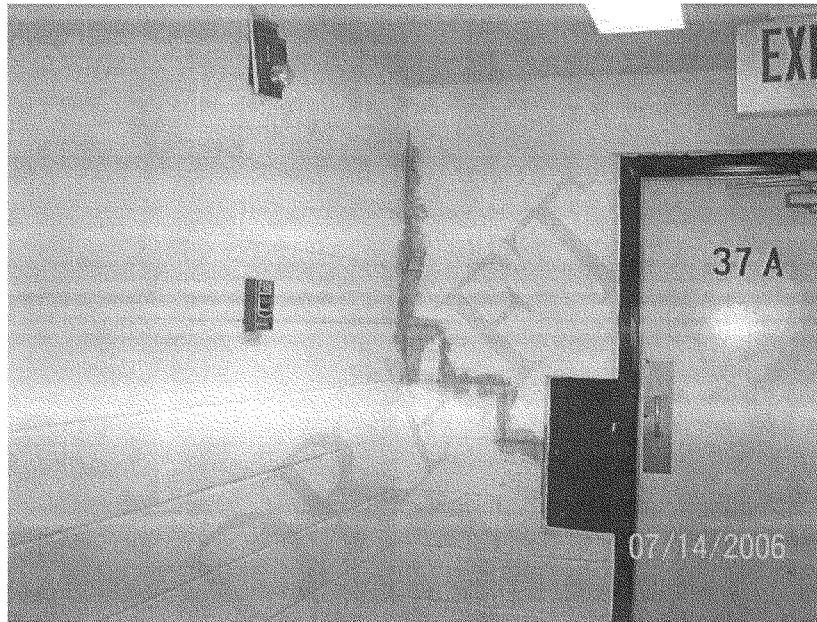
This temporary solution does not resolve the fundamental problem of a settling foundation

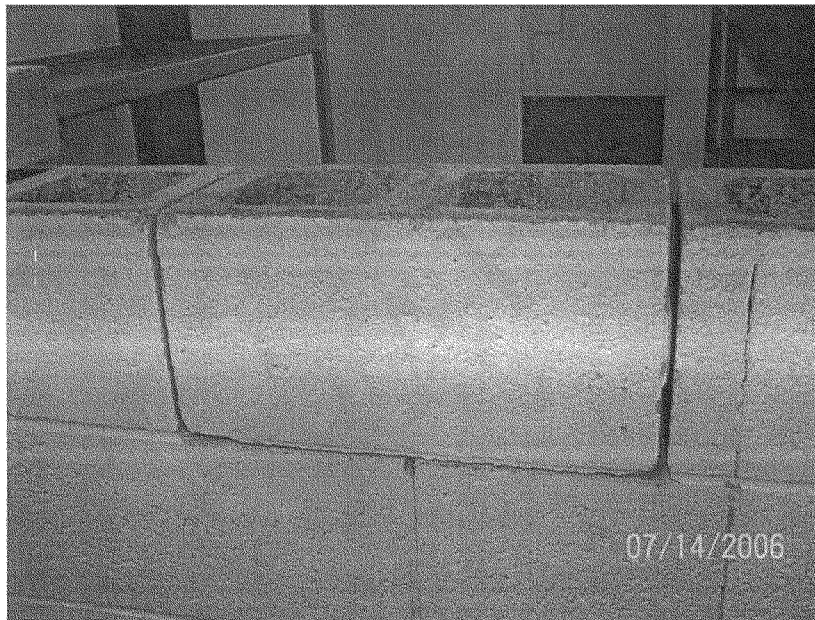
Partitioning walls at this facility have been compromised as a result of settling

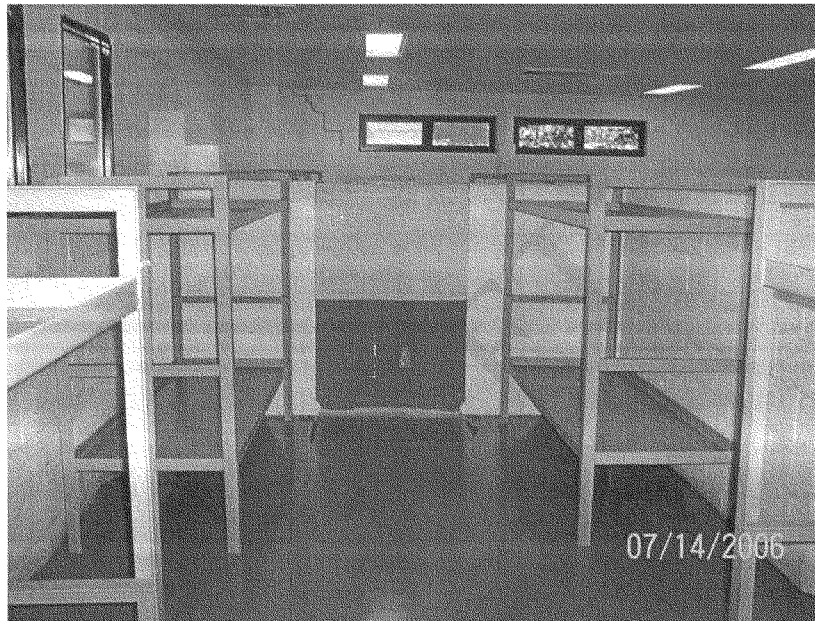
Inmates have used the settling as on the far exterior wall, to escape by scraping the mortar in the block wall, that remained after the crack opened

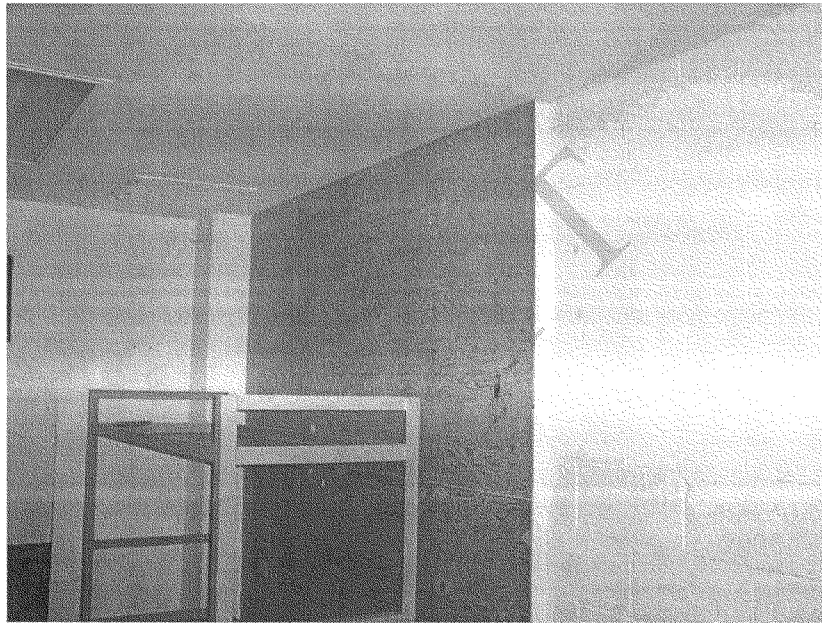
Covering up cracks with plywood does not resolve the fundamental problem

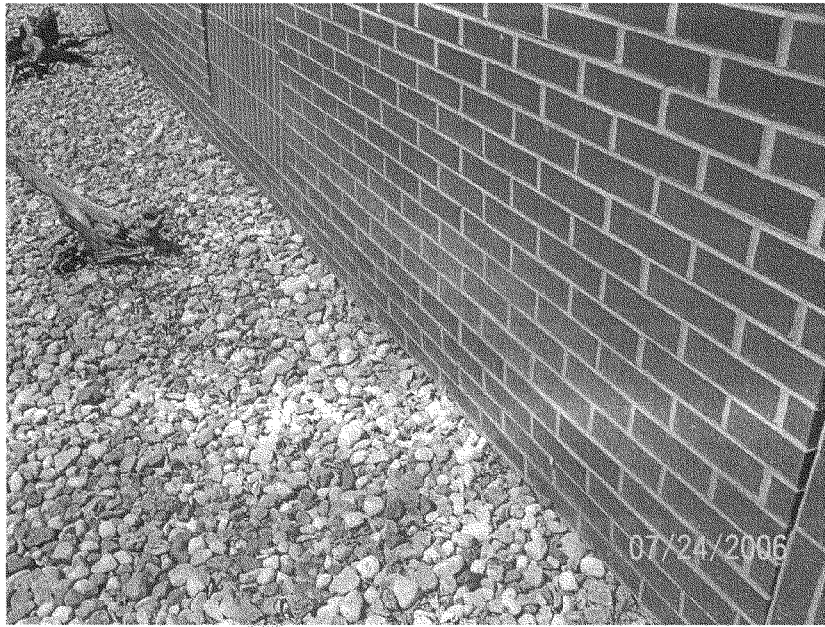
Bulging exterior wall

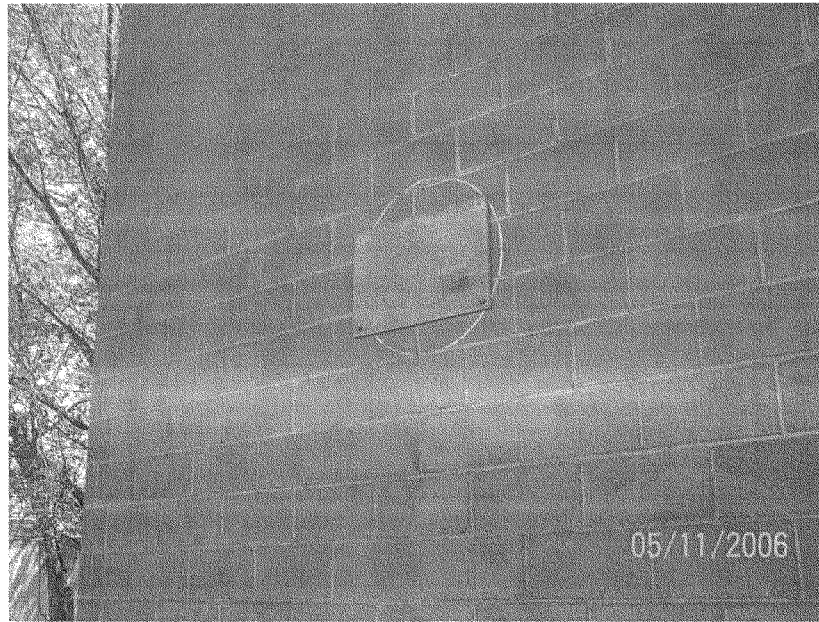
Plywood repair from an escape in the past

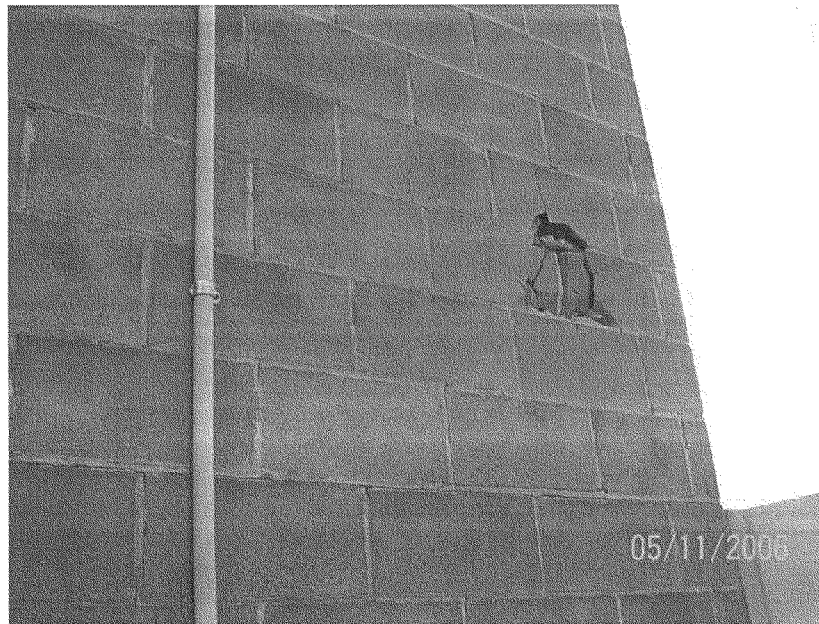
Exterior wall damage

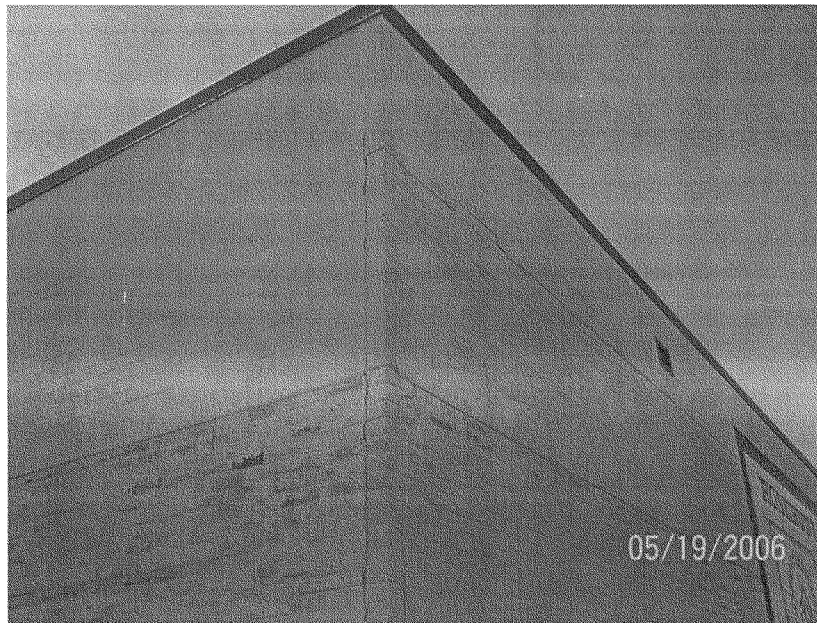
Stress on the walls resulting from settling foundation

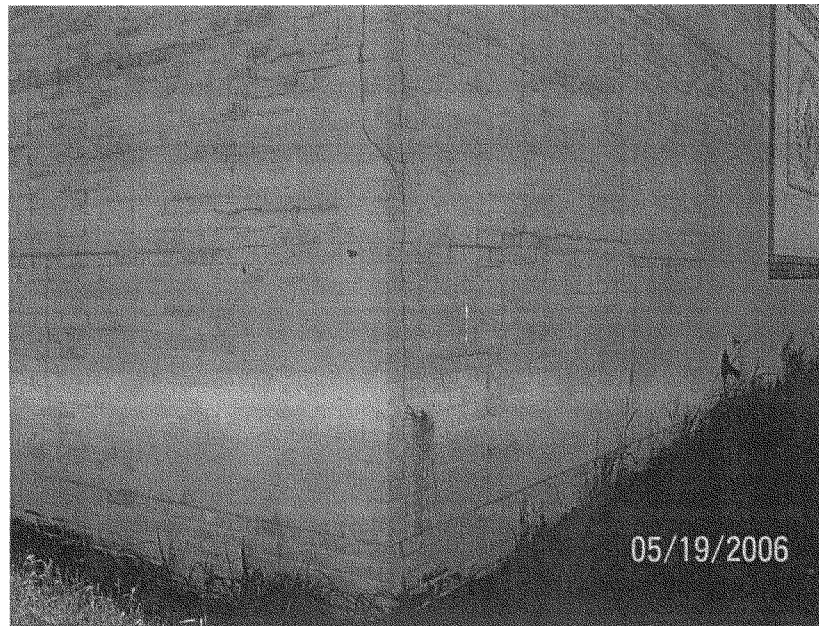
Stress on the walls resulting from settling foundation

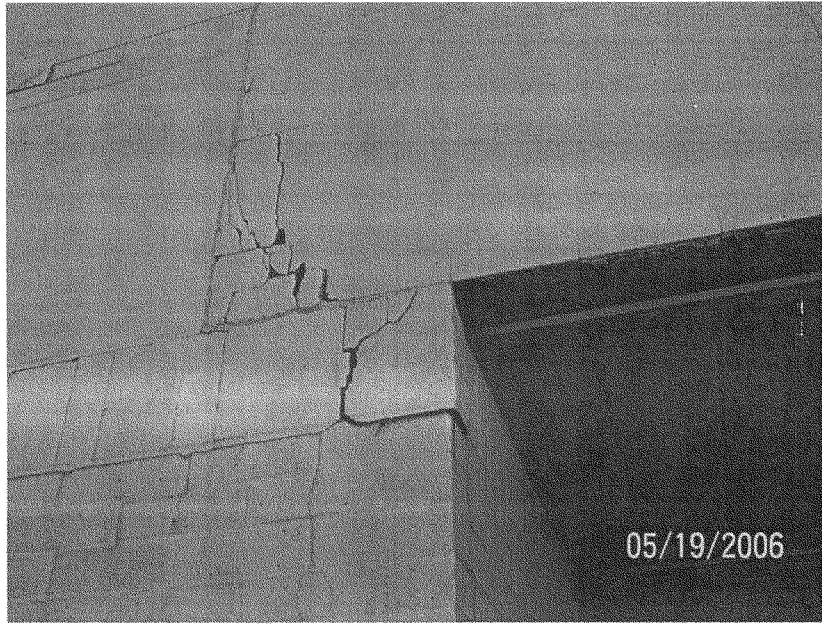
Stress on the walls resulting from settling foundation

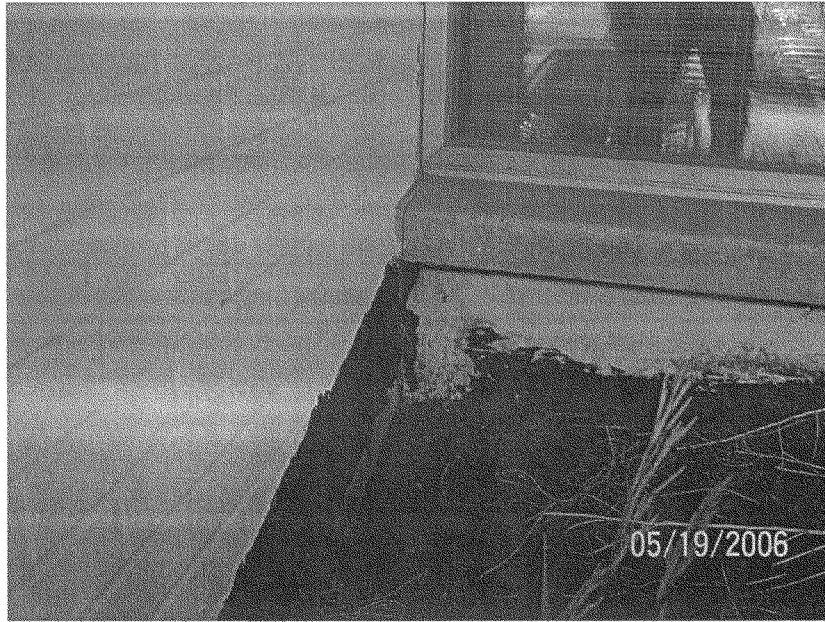
Soil collapsed along the weight bearing edge of the wall
